WIND DATA REPORT

Bishop and Clerks

March 1, 2005 – May 31, 2005

Renewable Energy Research Laboratory
University of Massachusetts, Amherst
160 Governors Drive, Amherst, MA 01003

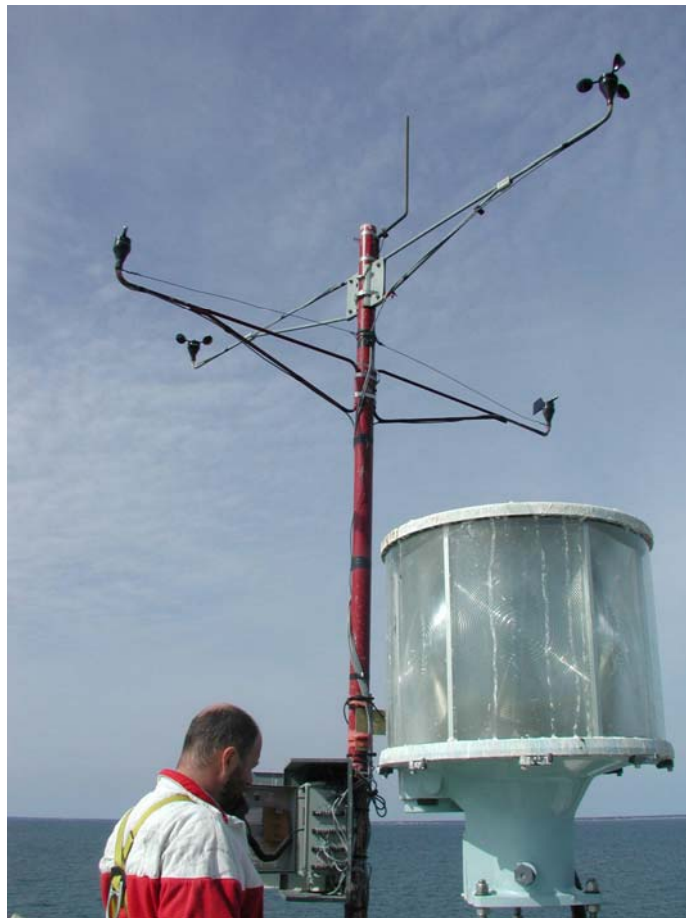
Figure 2 - Anemometry mast and data collection equipment at Bishop & Clerks

The wind monitoring equipment is mounted on a 12 ft long, 3" diameter, aluminum mast that is secured to the deck railing at the top of the lighthouse (Figure 2). All the remaining monitoring equipment comes from NRG Systems, and consists of the following items:

- Model 9300 Cellogger®, serial # 0258
- Electrical enclosure box with 5 watt PV panel
- Yagi directional antenna and mount
- 2 – #40 Anemometers, standard calibration (Slope - 0.765 m/s, Offset – 0.350 m/s)
- 2 - #200P Wind direction vanes
- 4 – Sensor booms, 43” length
- Lightning rod and grounding cable
- Shielded sensor wire

Limitations of this setup are that the mast height is low relative to the diameter of the lighthouse and the fact that the warning light and a PV panel mounted on top of the tower can interfere with the free flow of air. The mast height is limited by the stiffness of the railing. In fact, it was necessary to reinforce the free end of the railing to the USCG lighthouse PV panel brackets in order to use even the 12 ft mast (Figure 3) which otherwise shook severely in high winds.
