Renewable Energy Research Laboratory

Data Update for Bishop and Clerks, Nantucket Sound, MA October 2006

Monthly Data Summary for October 2006

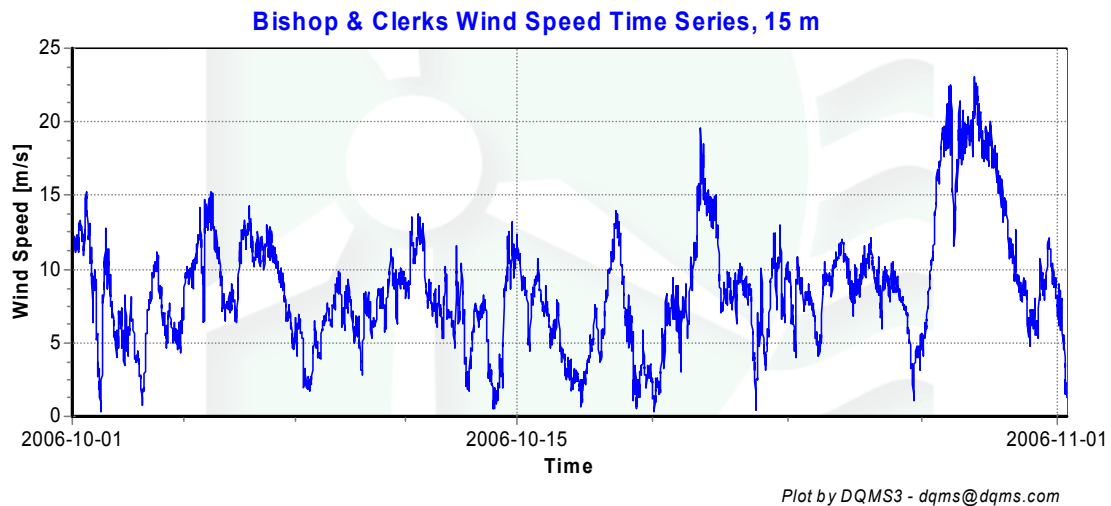
Seen below is a graph of wind speed at Bishop and Clerks for the month of October 2006, measured at the anemometer height of 15 m.
