Renewable Energy Research Laboratory

Data Update for Bishop and Clerks, Nantucket Sound, MA September 2006

Monthly Data Summary for September 2006

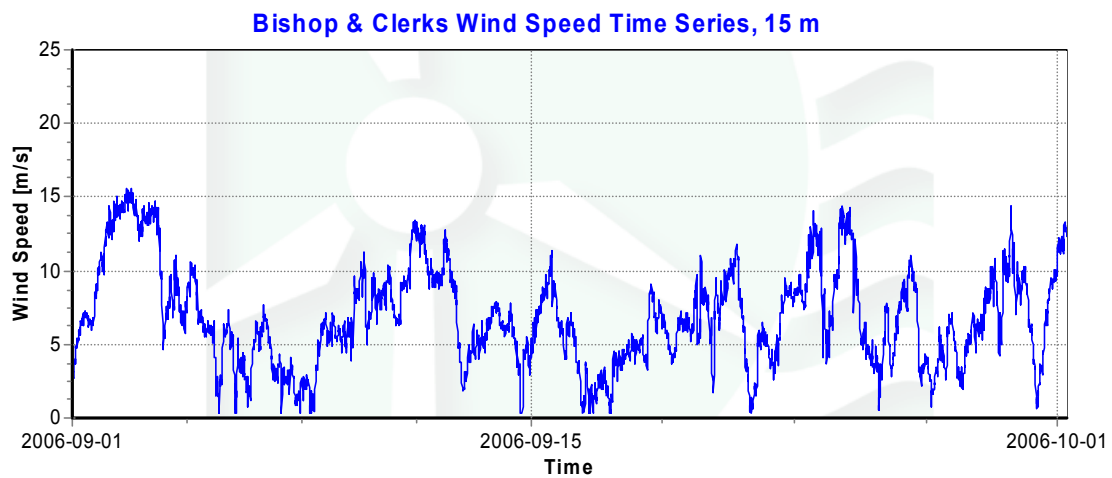
Seen below is a graph of wind speed at Bishop and Clerks for the month of September 2006, measured at the anemometer height of 15 m.
