Data Update for Thompson Island, Boston Harbor, MA August 2006

Monthly Data Summary for August 2006

This update summarizes the monthly data results for the Thompson Island monitoring site in Boston Harbor, MA, at 42° 18' 56" N, 71° 0' 40" W (NAD 83). More information on the sensors and site can be found at http://www.ceere.org/rerl/rerl_resourcedata.html.

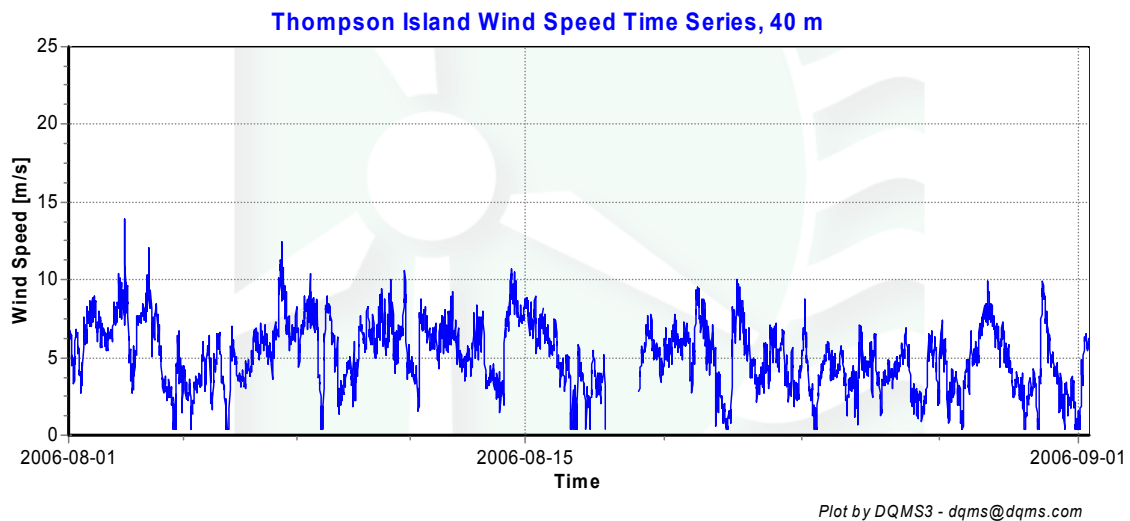
Seen below is a graph of wind speed at Thompson Island for the month of August 2006, at the highest anemometer height of 40 m.
