# Renewable Energy Research Laboratory

## Data Update for Marion: Great Hill Dairy August, 2009

### Monthly Data Summary for August, 2009

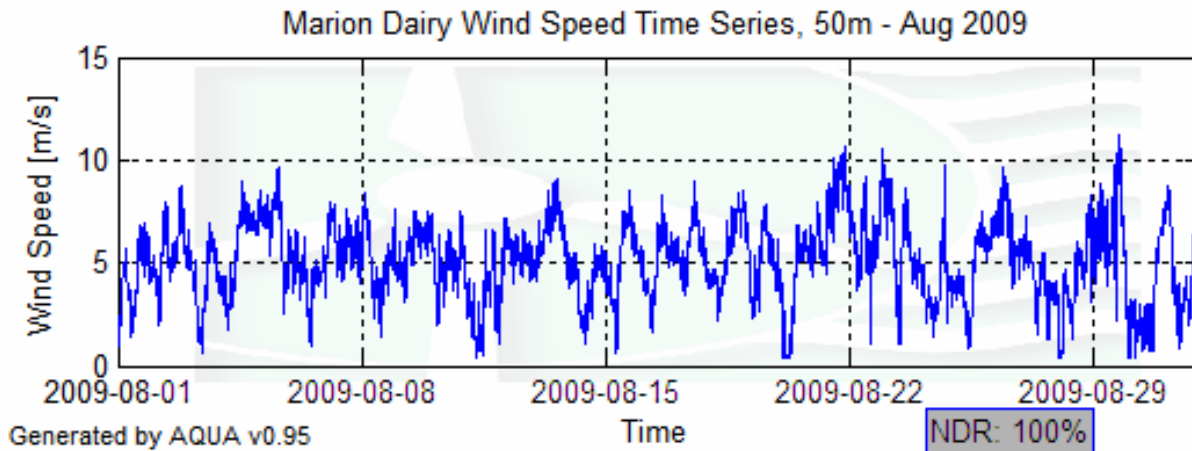
Below is a graph of wind speeds observed at the site for the month of August 2009.
