# Renewable Energy Research Laboratory

## Data Update for Thompson Island, Boston Harbor, MA April 2006

Prepared for  
Massachusetts Technology Collaborative  
75 North Drive, Westborough, MA 01581

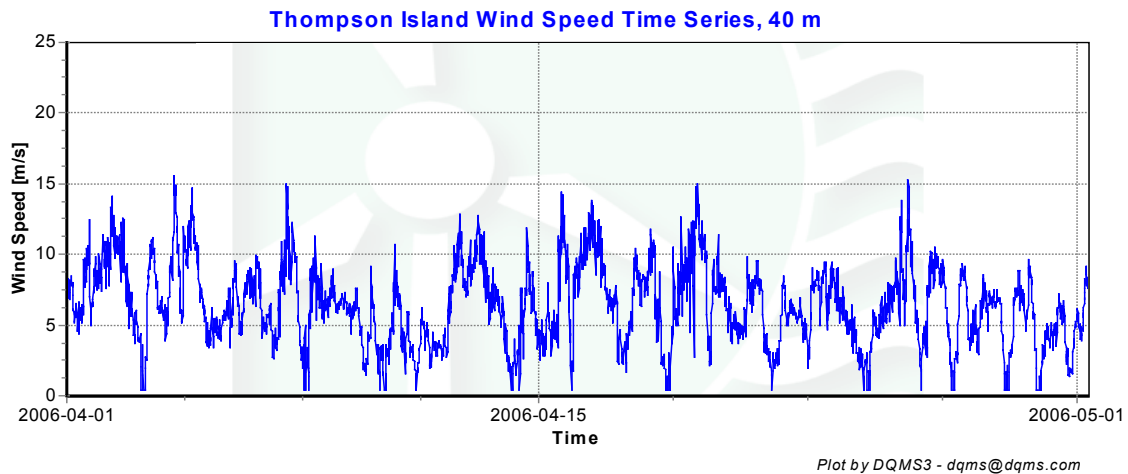
Seen below is a graph of wind speed at Thompson Island for the month of April 2006, at the highest anemometer height of 40 m.
